NZ Safety Alert

Worker injured when caught in conveyor

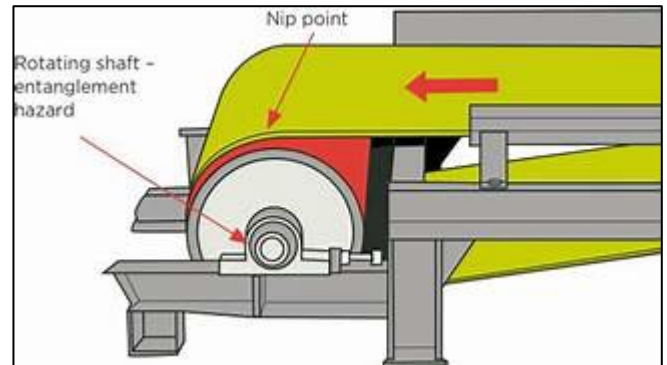
A worker was seriously injured when caught in a conveyor that he and another worker were conducting maintenance on.

While the incident is still under investigation, it would appear that the conveyor was running while the maintenance was being conducted and guards were not covering nip points.

1. All nip points are adequately guarded to ensure no-one can access the nip point.
2. Guards are designed and installed such that maintenance can be conducted without the need to remove the guard if plant is not isolated.
3. Checks are conducted to ensure all guards are fitted before plant is started, particularly after maintenance.
